What The Heck is Taking So Long!?

LH update September 25 by Bob Bourke

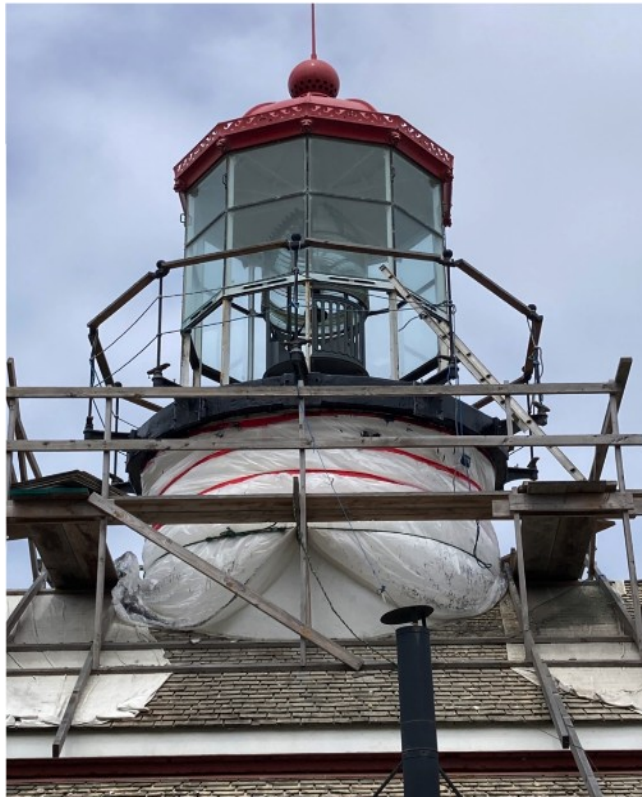
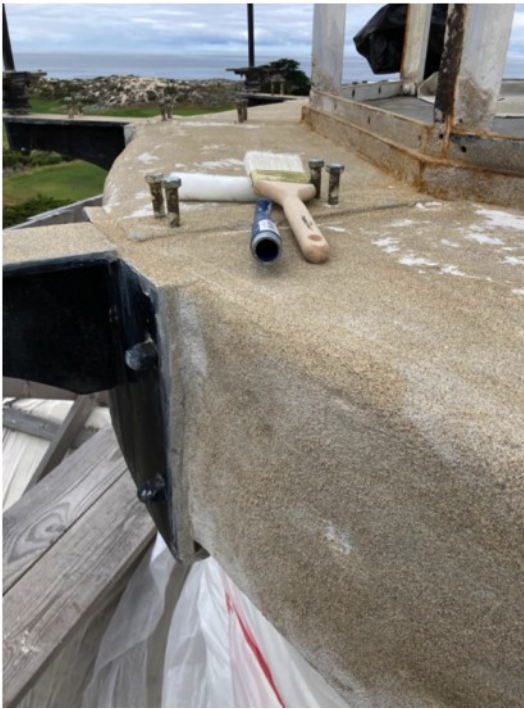
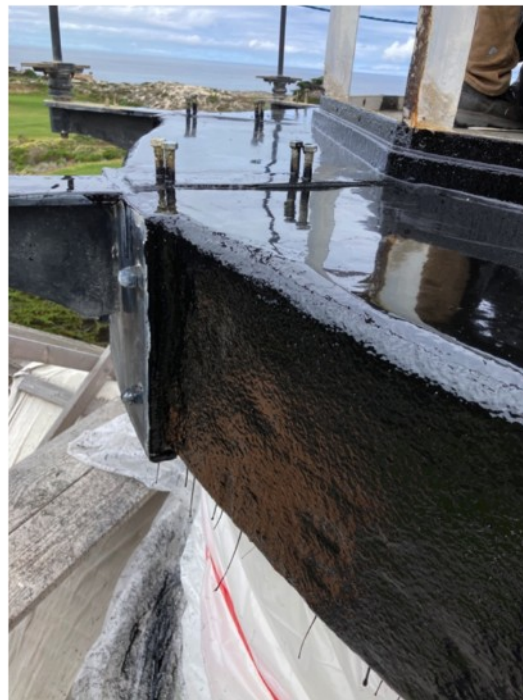
Epoxy coated concrete apron (L) with final coat of black rubberized paint (R)

All of the corroded concrete surfaces were ground or cut away and new specialized mortar was applied to cover the damaged areas, and then the entire surface was coated with 5 gallons of the special white two-part epoxy. This was then covered with another thick 5-gallon layer of black rubbery paint to completely seal and protect the concrete from further corrosion.
