## Historic Lighthouse Preservation:

# LANTERN

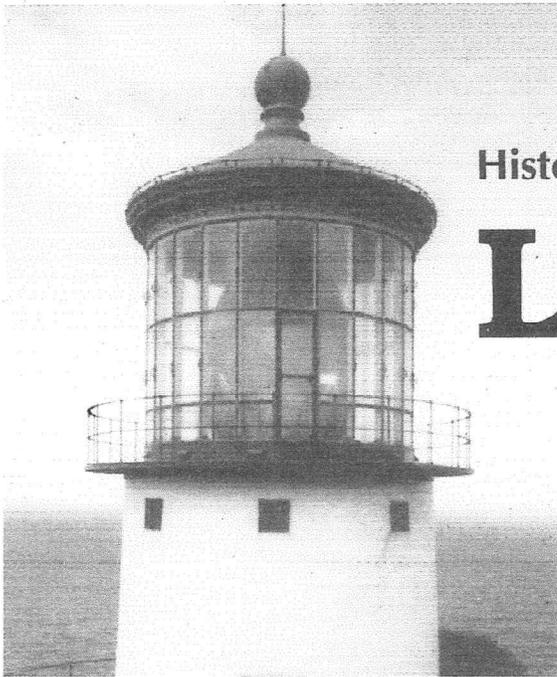
**Figure 1.** Lantern housing hyper-radiant lens at Makapuu Lighthouse near Waimanalo on the Island of Oahu in Hawaii

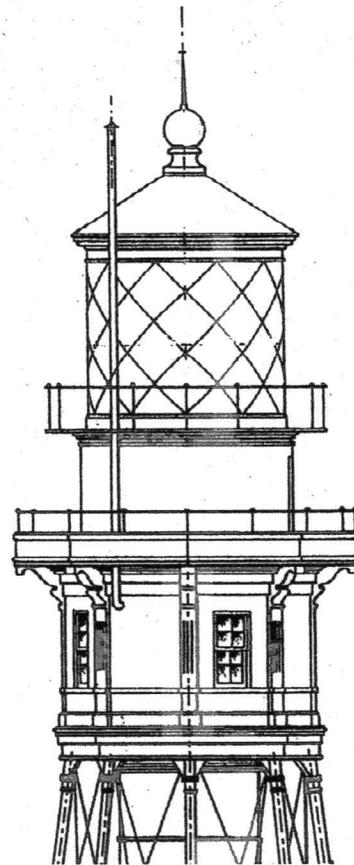
**Figure 2.** Original construction drawing of the first-order Cape Fear Lighthouse showing the lantern above the service/watch room.

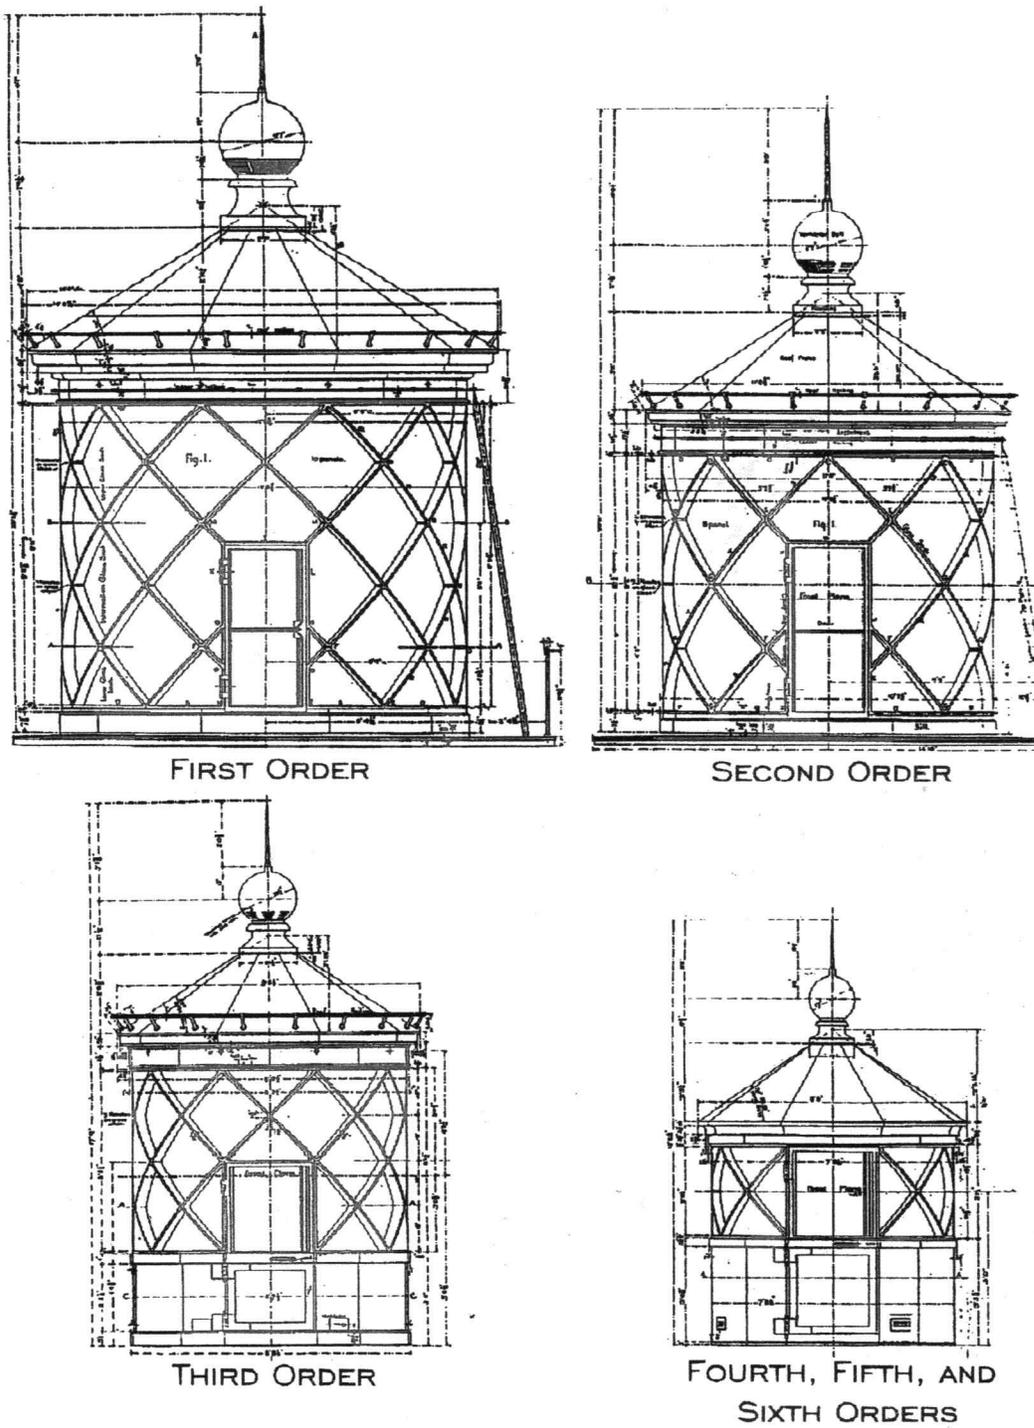
**Figure 3.** Illustration of the four standard lantern sizes used by the U.S. Lighthouse Establishment in the first half of the 20th century. Drawing assembled by WPTC from images dated 1898 and 1903 courtesy of USCG CEU Oakland.

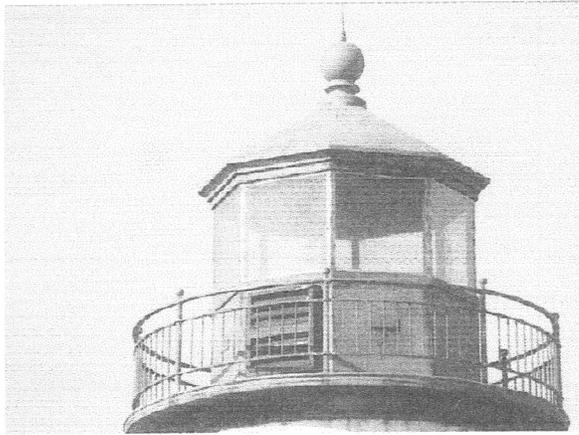
**Figure 4.** Close-up of the fourth-order lantern at Coquille River Lighthouse in Oregon.

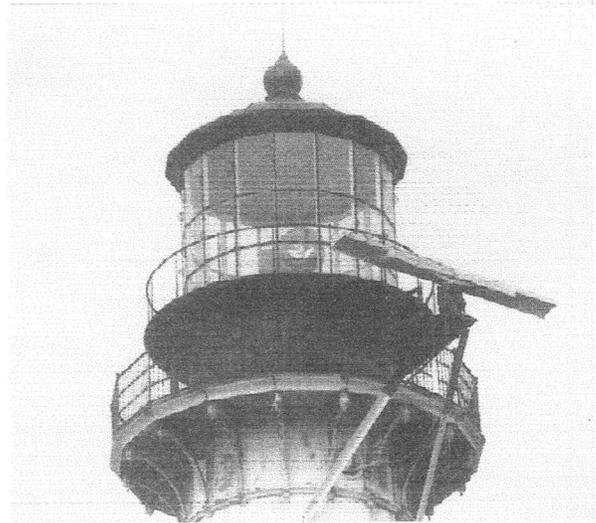
**Figure 5.** Close-up of the first-order lantern at Cape Canaveral in Florida.

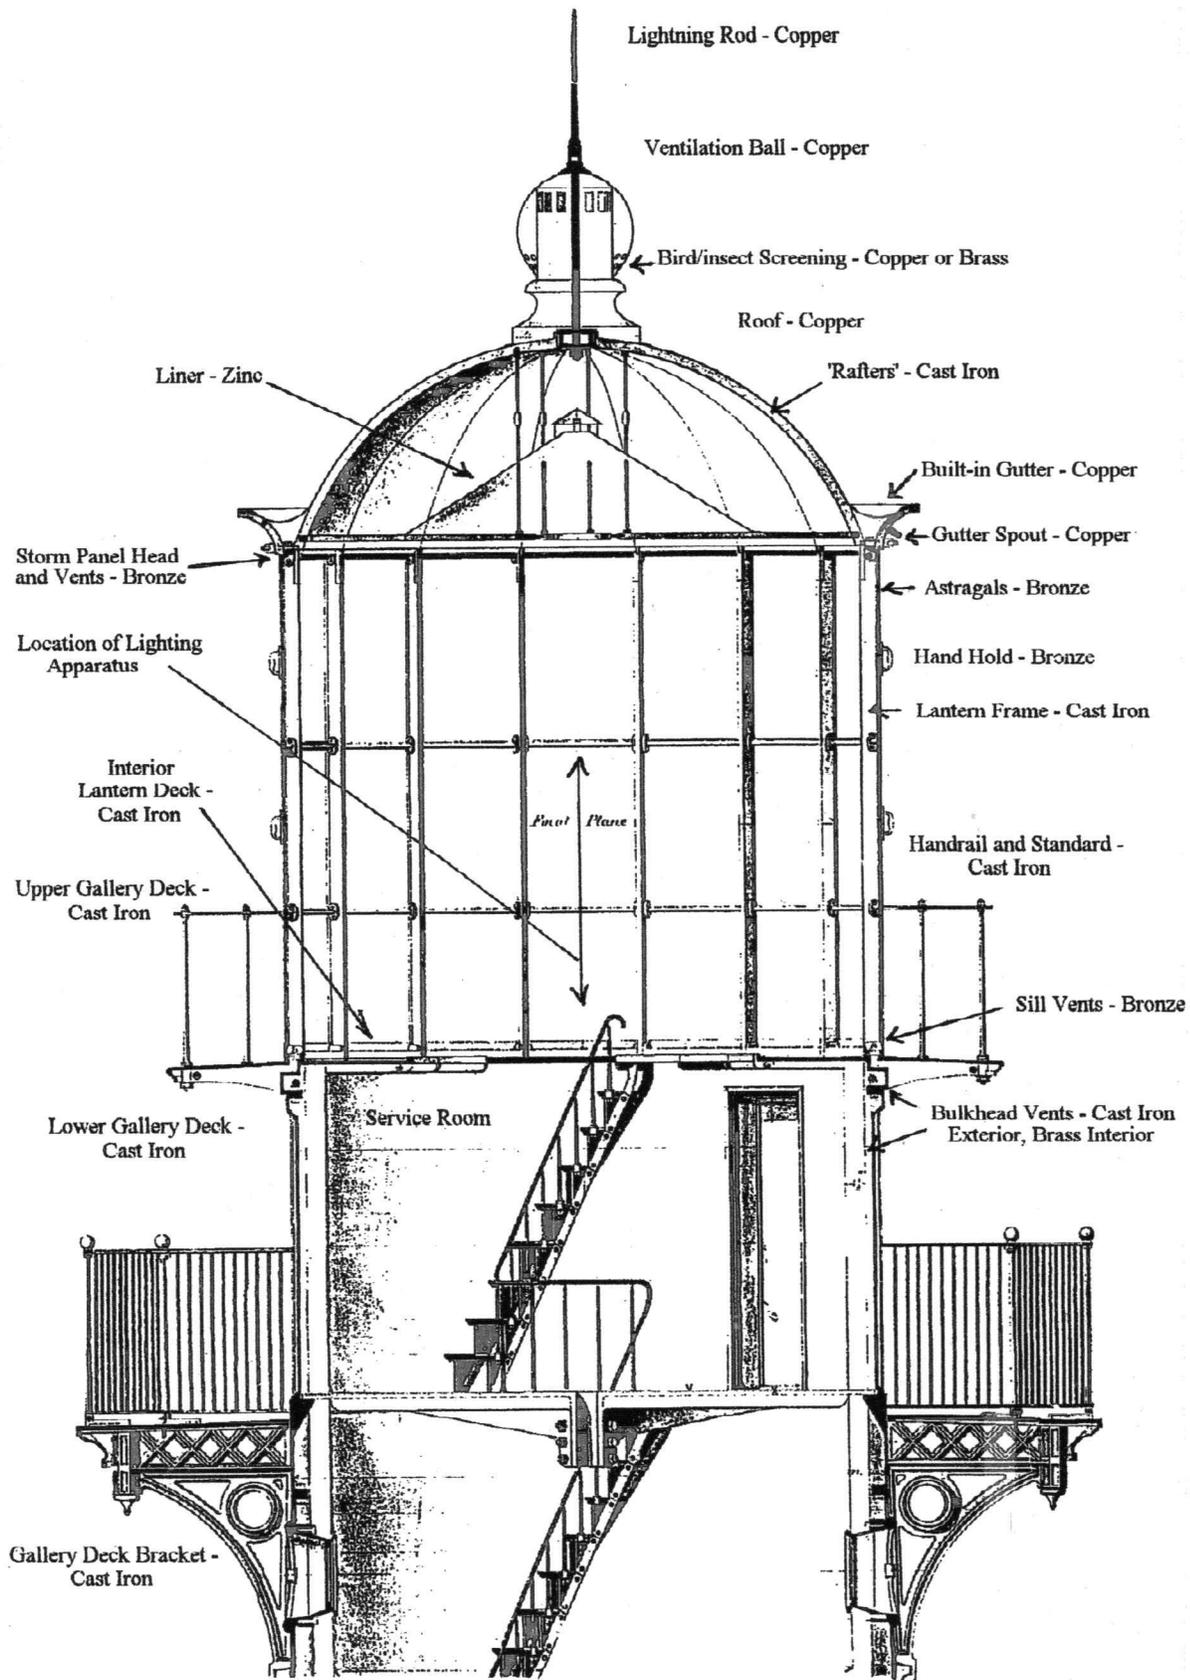
Figure 6. Diagram of a typical first-order lantern; the parts are similar to second- and third-order lights. (Diagram based on USLHS drawing in the National Archives)

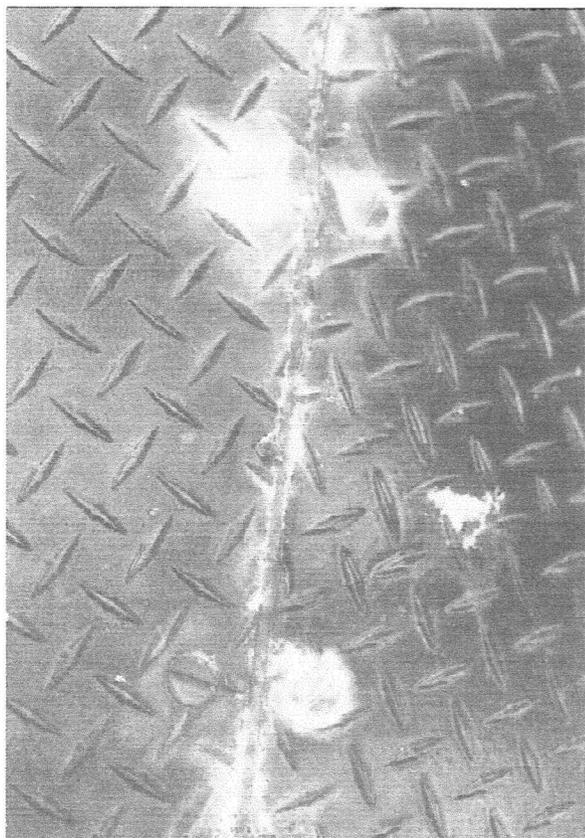
**Figure 7.** The white chalky residue around the steel bolt heads on this aluminum deck is the by-product of the corrosion occurring at these connections.

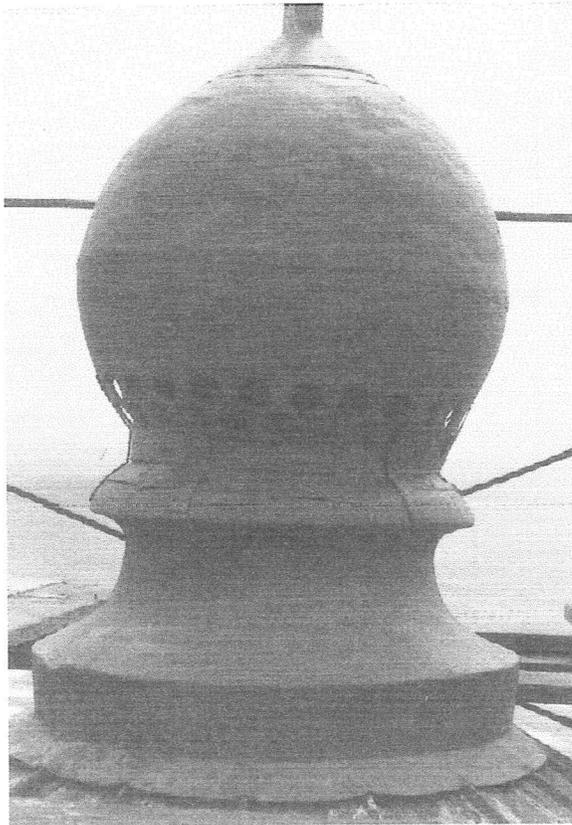
**Figure 8.** Despite the fact that this first-order lantern ventilation ball has been repaired several times, it still provides adequate lantern ventilation.

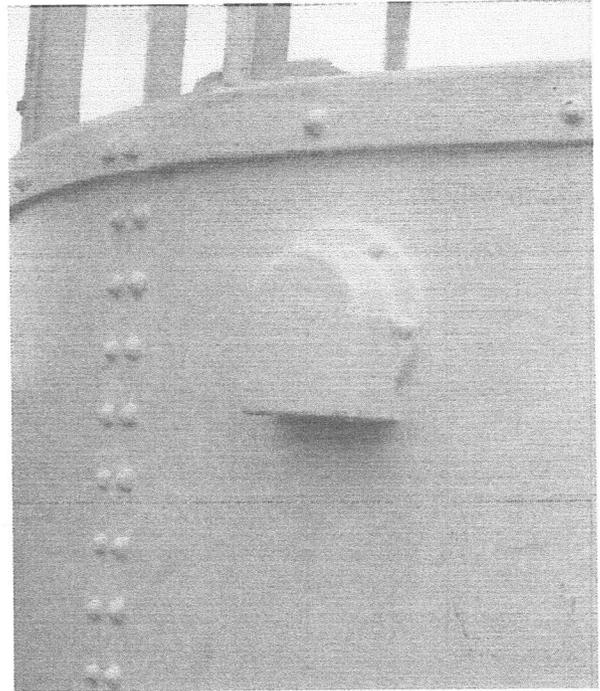
**Figure 9.** An example of a parapet-wall-mounted vent on a fourth-order lantern.

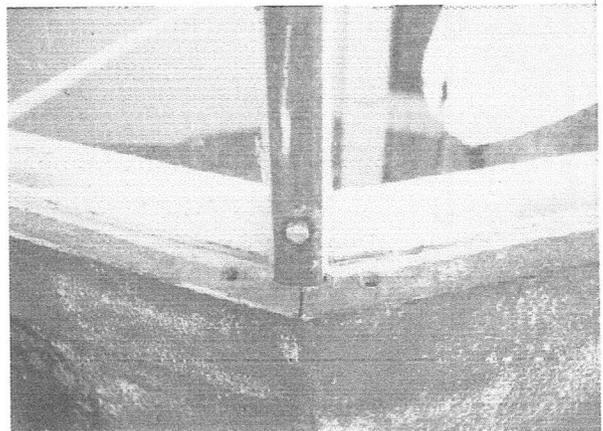
**Figure 10.** Close-up of missing clamp bolts; these bolts should be replaced to keep this area weather tight.

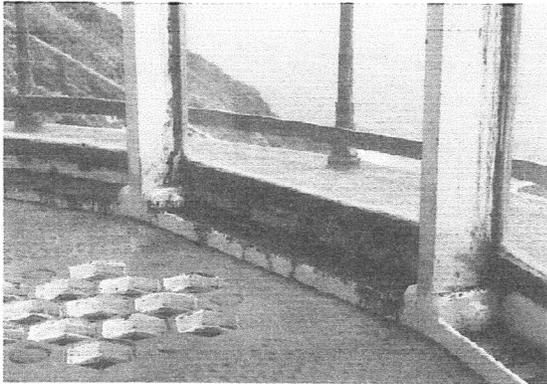
**Figure 11.** The water that has collected in this lantern sill is causing the iron lantern glass frame (the vertical members in the center of the photo) to rust and corrode.

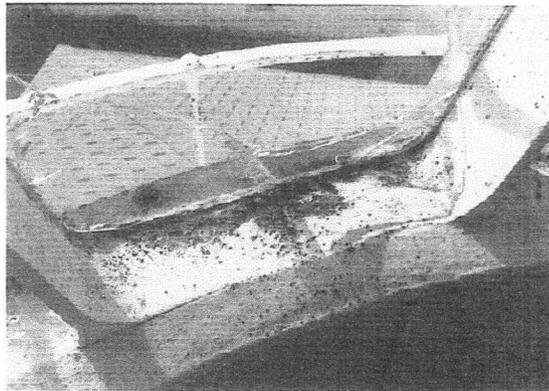
**Figure 12.** The glass in this lantern has been cracked by the rust-jacking that is occurring along the iron frame.

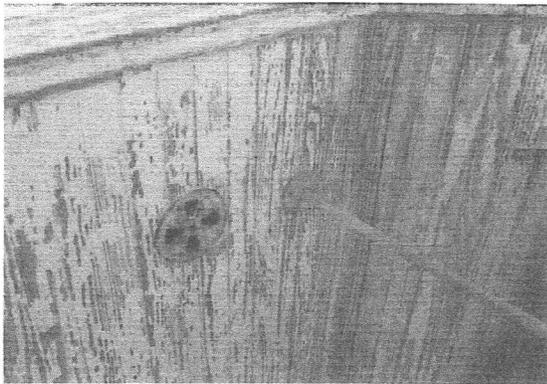
**Figure 13.** The paint coating that once protected this lantern parapet wall has failed.

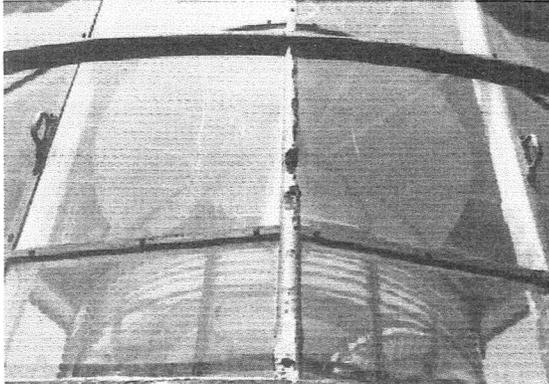
**Figure 14.** Wind and airborne sand have accelerated the deterioration of this lantern gallery deck handrail

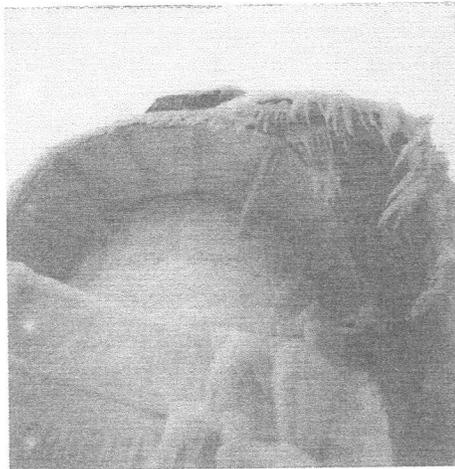
**Figure 15.** Close-up of ice on St. Joseph North Pier Lighthouse causing damage to gallery deck and handrail.

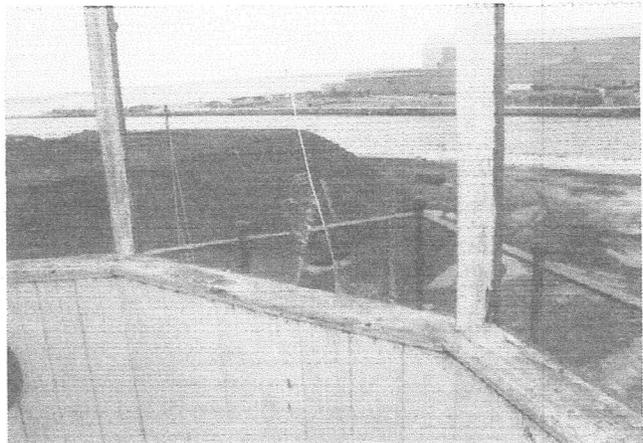
**Figure 16.** This lantern glass has been damaged by rock-throwing vandals. The resulting hole is allowing rain and insects to enter the lantern.

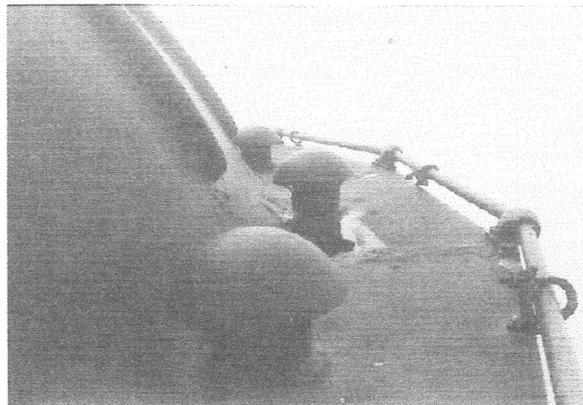
**Figure 17.** Roof vents such as these should be inspected for leaks and maintained during the mothballing period. This shroud-style vent allows air to pass while preventing rain from entering.

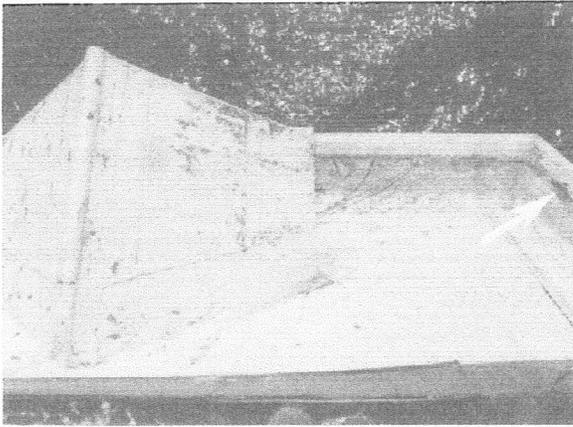
**Figure 18.** View of built-in gutter on a caisson lighthouse; arrow indicates fist-size hole. This condition must be treated before mothballing.

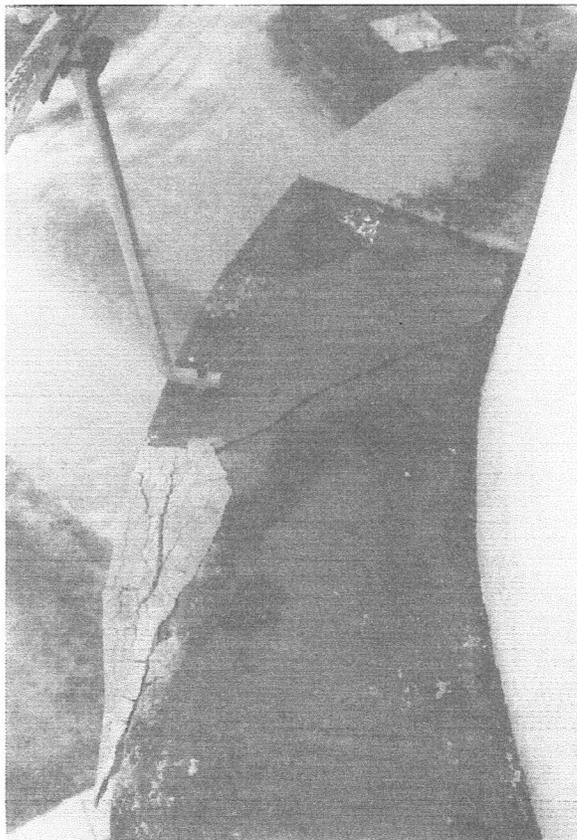
**Figure 19.** The repair made to this stone gallery deck has begun to deteriorate; moisture penetration is occurring. This condition should be addressed before mothballing.

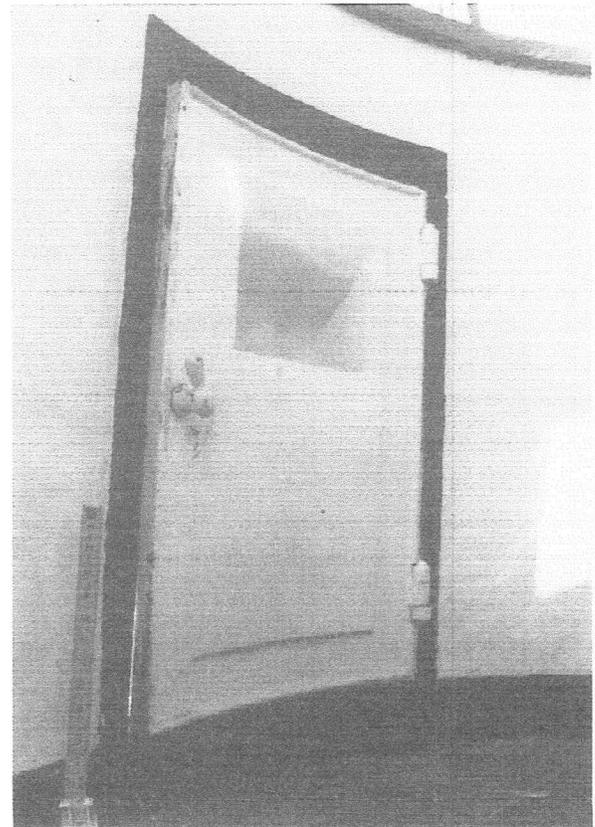
**Figure 20.** Close-up of a vented parapet hatch in a fourth-order lantern. The hatch should have a good seal and still remain operable. The built-in vent should also be kept open to maximize ventilation of the lantern and tower.

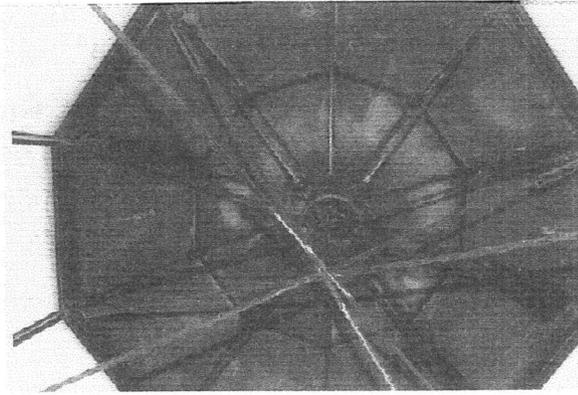
**Figure 21.** The diagonal tension rods in this empty lantern were installed to brace the lantern against lateral loading caused by high winds.

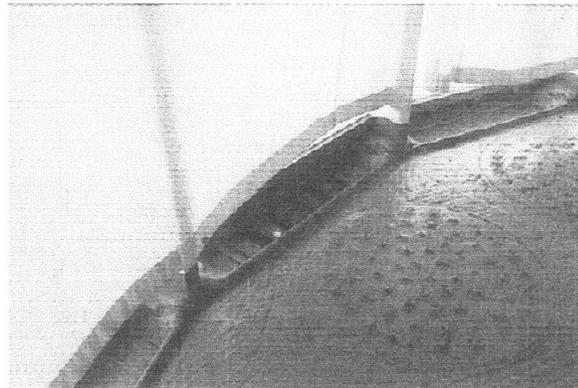
**Figure 23.** As part of the lantern mothballing treatment the lantern glass sill vents should be kept open (except in extremely damp climates) to allow for the free flow of air through the lantern.
