## Fire Protection

## Repair

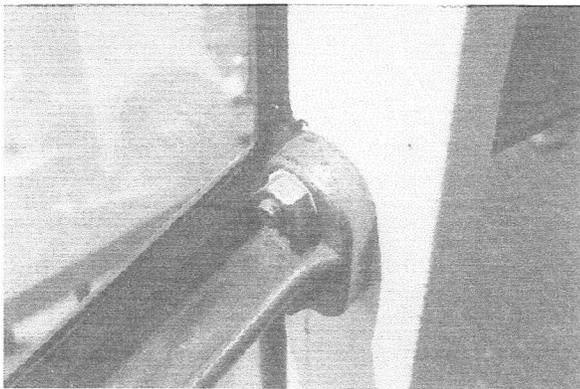
**Figure 24.** The stainless steel through bolts used to join this bronze sash bar to the vertical lantern post is isolated from the bronze using a nylon washer as a barrier.

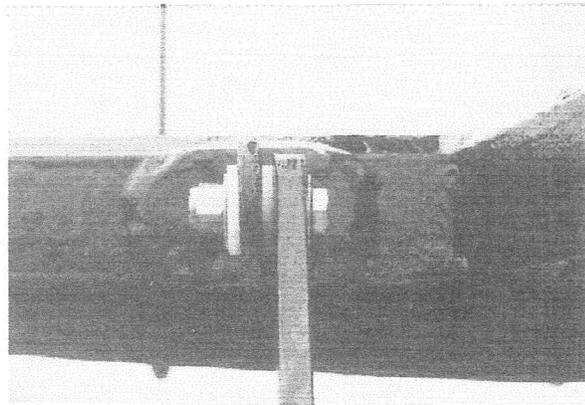
**Figure 25.** This is a view of a typical dissimilar metal isolation solution; the steel ladder post (vertical member in the center of the image) is isolated from the aluminum lantern gallery deck with nylon washers. The bolt chosen for this application is made from Type 316 stainless steel.

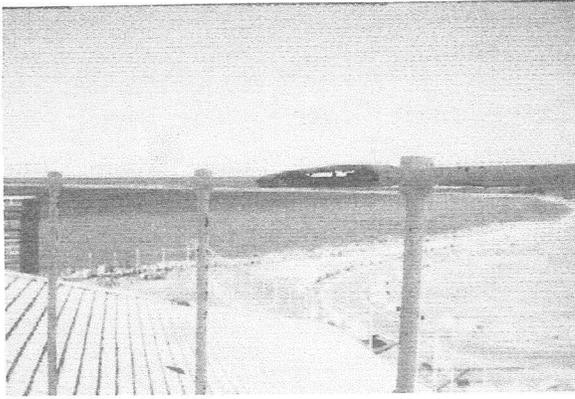
**Figure 26.** Detail of handrail that is being deformed by rust-jacking.

- Prohibit the infiltration of water into gaps between iron lantern frames and bronze window sub-frames, as well as other seams in iron or steel components.
- Maintain coatings and detailing that divert and shield water away from members that are prone to rust-jacking.
- When iron or steel components are repaired, be sure to coat any areas that have had their finish

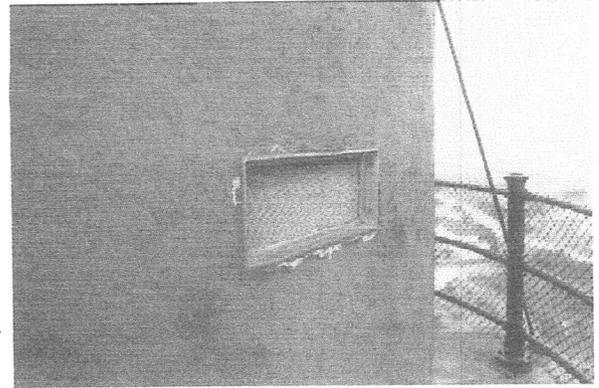
**Figure 27.** This lantern vent opening has been covered with a fine stainless steel screen that prevents insect infiltration while maximizing air movement through the vent and into the lantern.

Nearly all, if not all, lanterns have a ventilation-ball-type vent and baffled secondary vents in various locations in the lantern and service room. These vents provided the fresh air for the illuminant and created a light draft that minimized condensation buildup inside the lantern. Air flow through the vents was also controlled by a variety of sliding registers and/or rotating dampers. To maintain an ambient humidity level in the lantern, the built-in ventilation system should be in working order, with all possible vents open to allow the maximum amount of air exchange to occur in the lantern. The exterior vent openings should be screened with brass or stainless steel screen to prevent bird and insect infiltration. Opening the lantern vents will aid in the overall ventilation of the lantern.

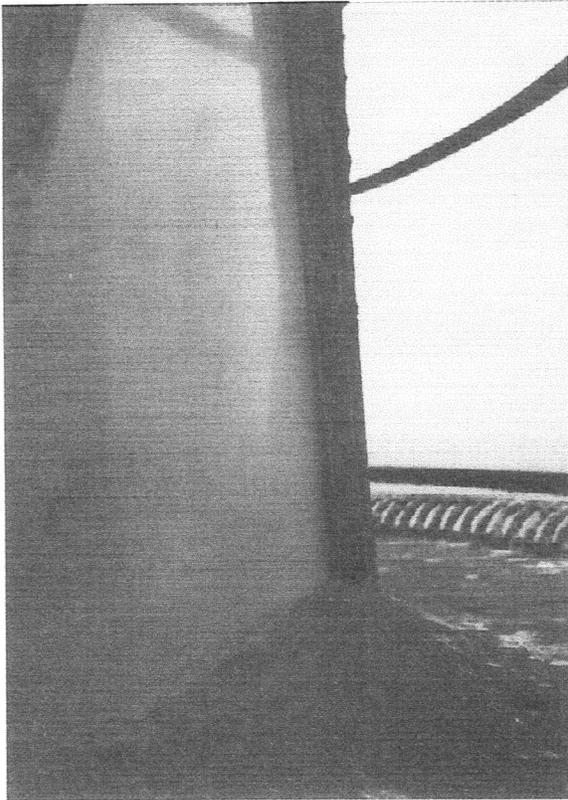
**Figure 28 (top left).** Close-up view of severely hazed Lexan replacement panel. Note the limited visibility caused by only ten years of sunlight and salt air exposure.

In 1986 the wire-glass in the lantern of the Sombrero Key Lighthouse was replaced with Lexan (plastic) panels. A 1996 site visit found the Lexan panels hazed by sunlight and salt air exposure. This condition greatly reduces the transmission of light and therefore reduces the effective range of the aid to navigation. The inability of the Lexan panels to withstand the conditions of the marine environment gives the panels a short life expectancy when compared to glass. With these inherent limitations, Lexan or other plastic panels should only be used as a temporary repair and not be relied upon as a long-term lantern glass material.

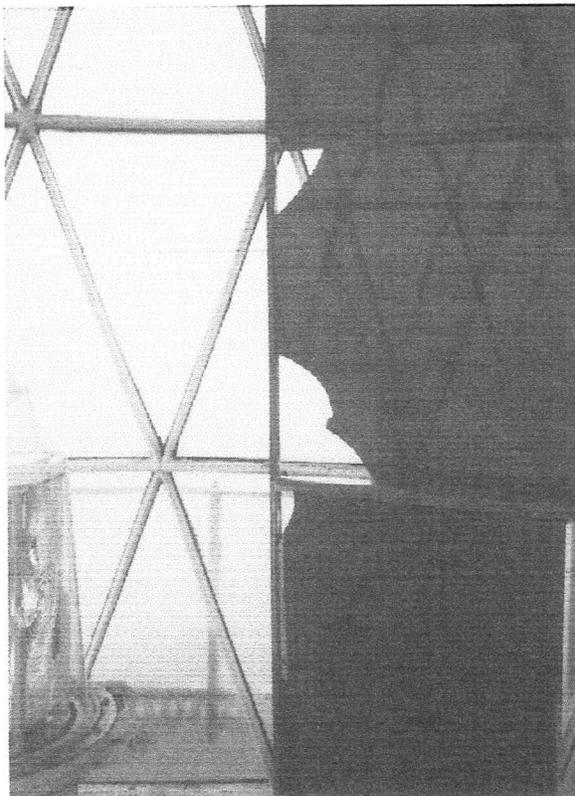
**Figure 29 (bottom left).** Looking out through severely hazed Lexan panels, note the limited amount of light transmission; this greatly hinders the effectiveness of the aid to navigation. If the panels are not replaced, the degradation may continue and diminish the light transmission, ultimately rendering the aid to navigation ineffective.

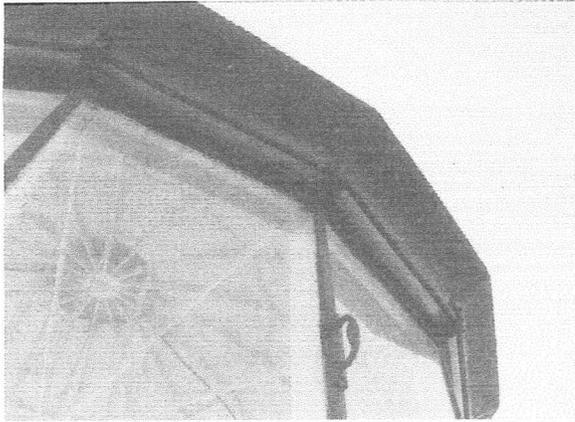
**Figure 30.** Close-up of a first-order lantern that retains its lantern glass; note the clarity.

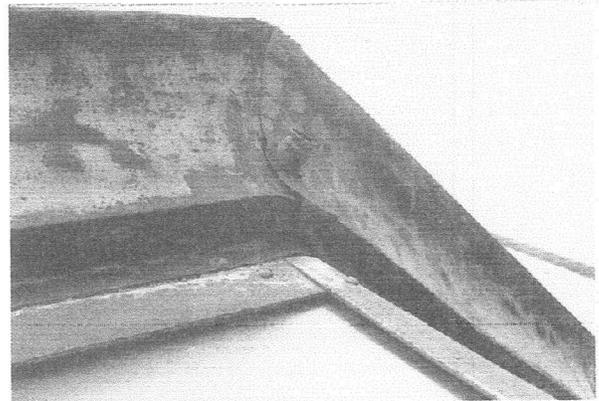
**Figure 31.** View of built-in gutter spout on a copper roof.

All rainwater guttering systems (lantern roofs or other tower roof forms) should be cleaned and checked for holes. All holes and non-functioning gutter system components should be repaired. Holes in sheet-metal built-in gutters must be repaired with a properly soldered repair to ensure the durability of the repair. Caulking should be considered only for temporary repairs until a proper soldered repair can be

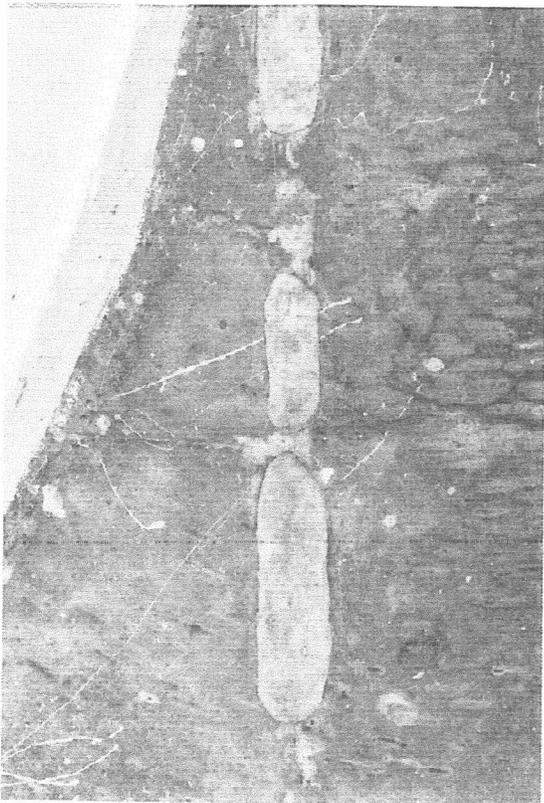
**Figure 32.** This sheet-copper-covered lantern gallery deck has been repaired several times by soldering sheet copper patches over the holes. This method of repair, if performed properly, greatly increases the life span of the roof covering.

- When repairing gallery decking, use only like-kind materials.
- The decking should be sloped away from the lighthouse to shed the water away from the structure.
- Inspect all seams for water infiltration: in cast-iron decking there will be raised corrosion along the length of the seam; with flat-seam sheet metal there may be a leak present on the interior of the lighthouse; in stone decking there may be open gaps between the pointing and the stones.
- Flat-seam sheet-metal decking should be repaired with soldered patches or with selective removal and replacement with like-kind material; all new seams should be double locked and soldered.
- Cast-iron decking should first have all corrosion removed and the affected surfaces painted with

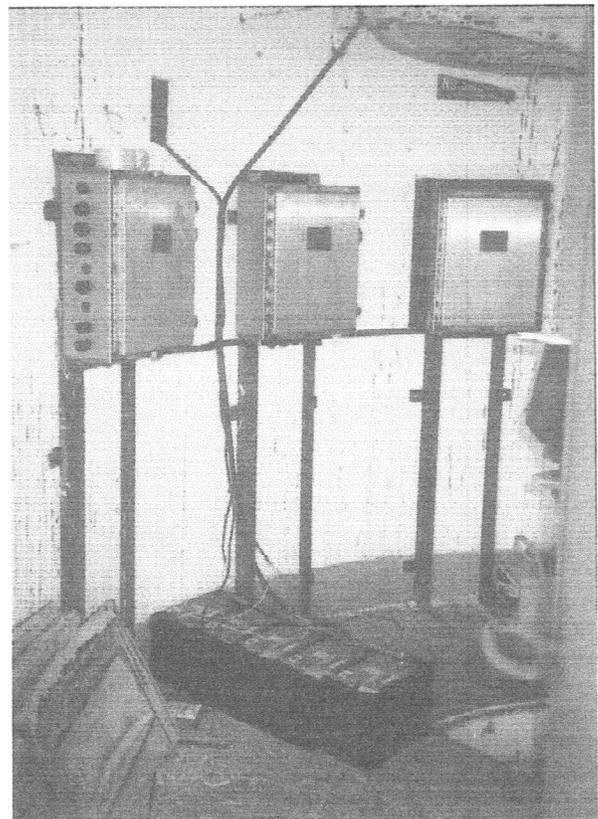
**Figure 33.** To minimize damage to historic wood beadboard panelling, these new panels should have been installed on a sheet of plywood attached to the historic wood beadboard panelling in four locations. These batteries stored on the floor should be in containment boxes in case the batteries leak.

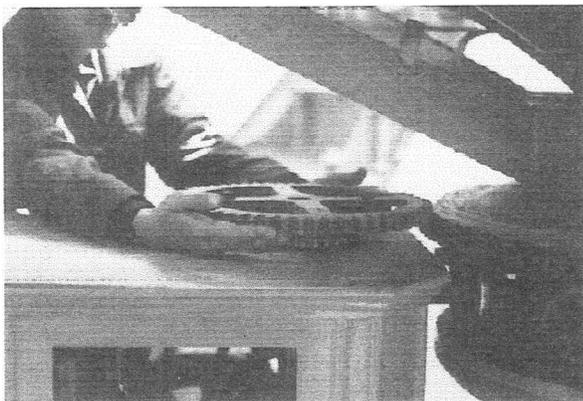
**Figure 34.** When this first-order classical lens was converted to AC power, the original drive gear (pictured here) was the crank used to wind the clockworks.

- When a classical lens has been converted to AC or solar power, retain the extant accessories such as lens jacks, clockwork cranks, wrenches designed for use with the lens, etc., that were used for the care and maintenance of the lens.

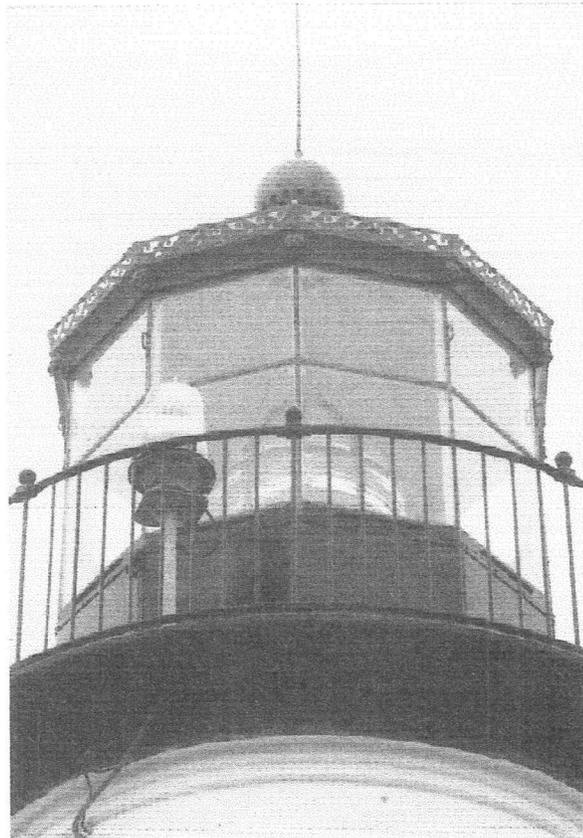
**Figure 35.** This is an acceptable auxiliary light installation. The light is mounted on an aluminum pedestal that has been bolted to the replacement aluminum deck.

- Avoid mounting heavy solar panels and auxiliary lights on the outside of historic gallery deck rails; this will create eccentric loading that will ultimately damage the railing.

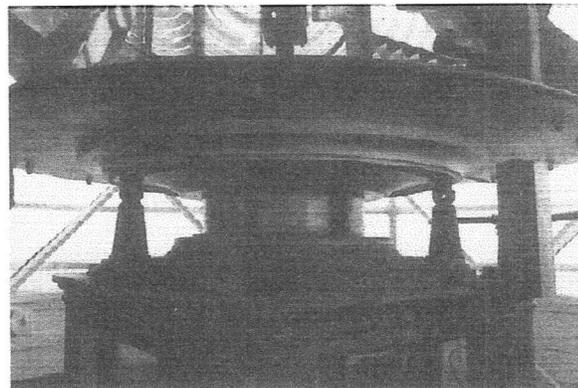
**Figure 36.** This c. 1926 lens was designed to be AC powered; the original lens jacks are still in place. The three jacks (the third is obscured by the brass bearing cover) were used to lift the lens assembly so that bearings could be serviced.
